Aviation Investigation Preliminary Report

Location:	Bath, MI	Accident Number:	ANC26FA002
Date & Time:	October 16, 2025, 17:28 Local	Registration:	XA-JMR
Aircraft:	Raytheon Hawker 800XP	Injuries:	3 Fatal
Flight Conducted Under:	Part 91: General aviation - Business

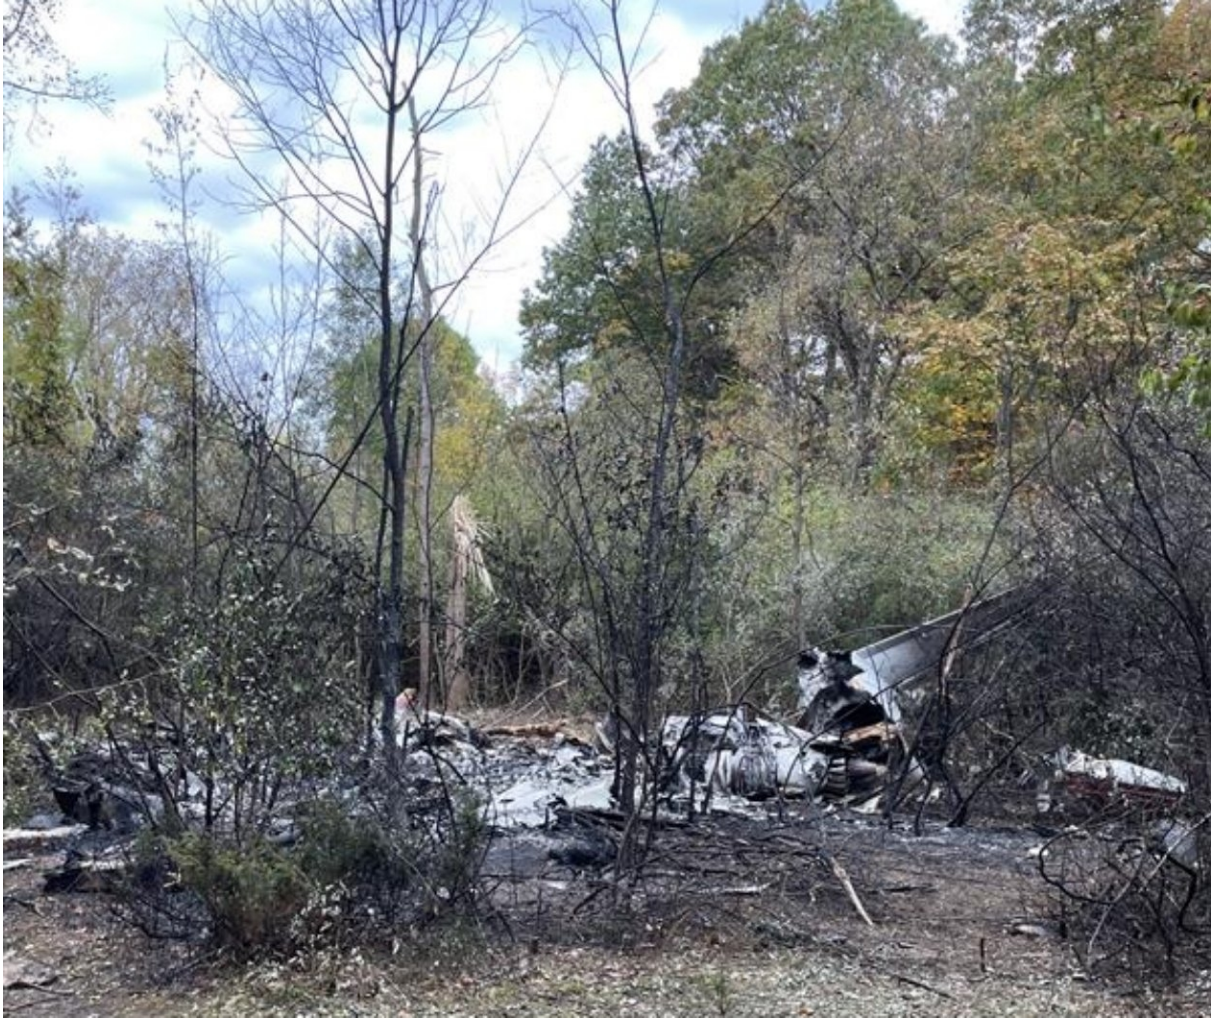
The airplane came to rest in a wooded area about 9 miles northeast of BTL at an elevation of 850 ft mean sea level and oriented on a magnetic heading of 150°. The airplane impacted terrain in a relatively flat attitude. A postimpact fire consumed a large portion of the main wreckage with the exception of a portion of the right wing, both winglets, and the empennage section. All major structures were accounted for at the accident site.

Figure 1 View of accident site main wreckage.
