Aviation Investigation Preliminary Report

Location:	Huntington Beach, CA	Accident Number:	CEN26FA015
Date & Time:	October 11, 2025, 14:01 Local	Registration:	N222EX
Aircraft:	Bell 222	Injuries:	3 Serious, 2 Minor
Flight Conducted Under:	Part 91: General aviation - Personal

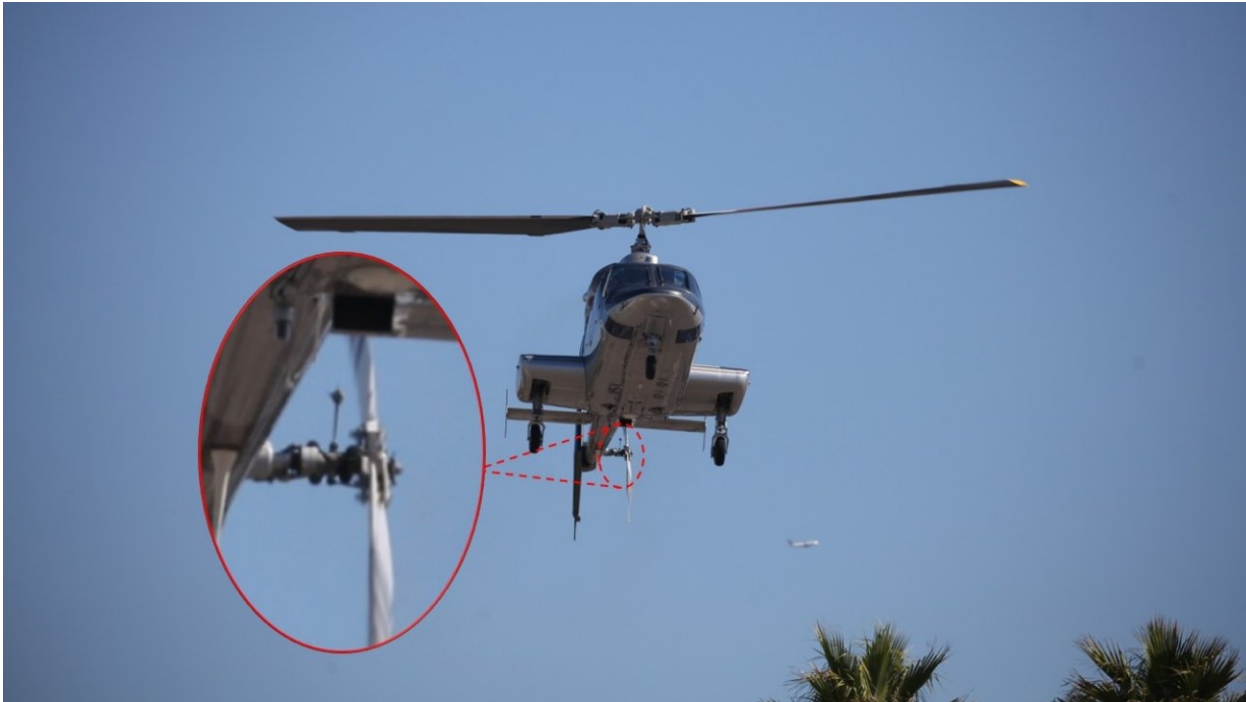
Witness photos and videos revealed that during the high-speed pass, there were no apparent anomalies with the helicopter. During the slow pass, one of the tail rotor pitch links was disconnected from a tail rotor blade. As the helicopter approached the parking lot for landing, the pitch link remained disconnected (see figure 1).

Figure 1. The accident helicopter before landing. A red callout shows a zoomed in view of the tail rotor assembly and a disconnected pitch link.

Postaccident examination of the separated tail rotor assembly revealed that both pitch horns were fractured in half. All pitch horn bolts and associated hardware remained installed and secure.
