# Aviation Investigation Preliminary Report

| <b>Location:</b> | Moab, UT | <b>Accident Number:</b> | DCA26LA012 |
| <b>Date &amp; Time:</b> | October 16, 2025, 06:43 Local | <b>Registration:</b> | N17327 |
| <b>Aircraft:</b> | Boeing 737 | <b>Injuries:</b> | 1 Minor, 111 None |

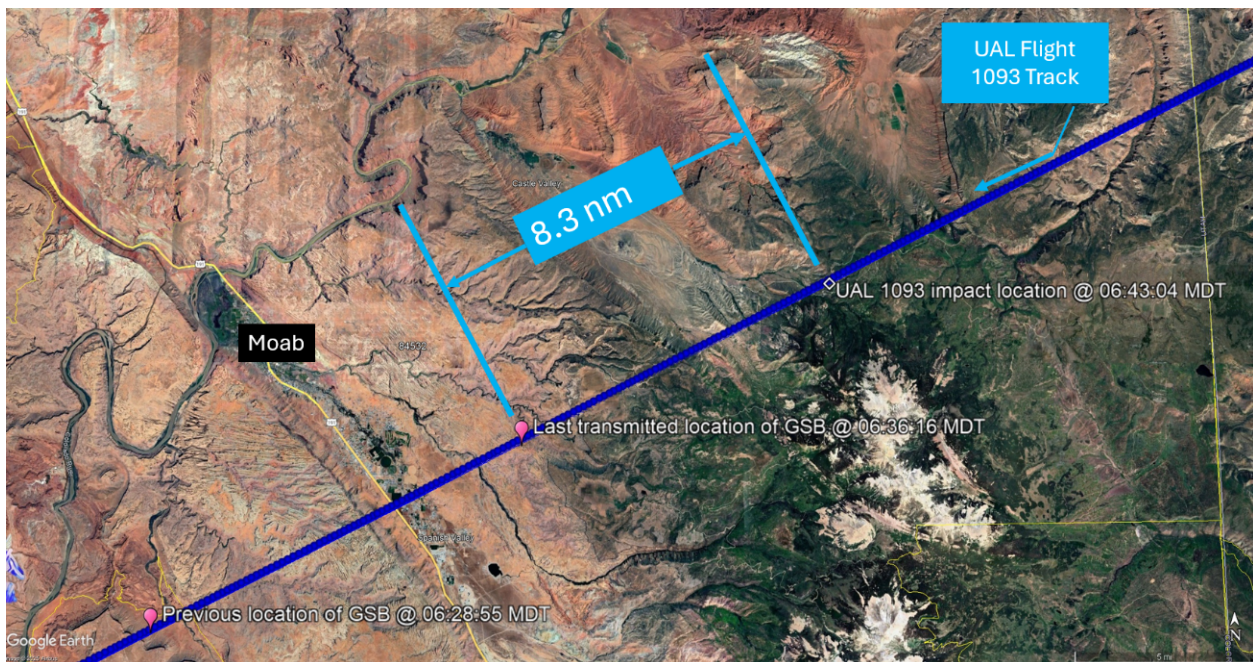
In addition, the flight data and the cockpit voice recorder were sent to the NTSB Vehicle Recorder Laboratory in Washington, DC. A preliminary review of the data from the cockpit voice and flight data recorders revealed that at the time of the collision, the airplane's track was to the southwest at 233° magnetic (nearly the reciprocal of the balloon track), at a pressure altitude of 36,002 ft, and a groundspeed of 395 knots.

**Figure 5.** UAL flight 1093 ground track and GSB locations.
